04/28/88 Aloha Airlines

Report Number NTSB/AAR-89/03

Report Title Aircraft Accident Report--Aloha Airlines, Flight 243, Boeing 737-200, N73711, near Maui, Hawaii, April 28, 1988

Report Type Aircraft Accident Report April 28, 1988

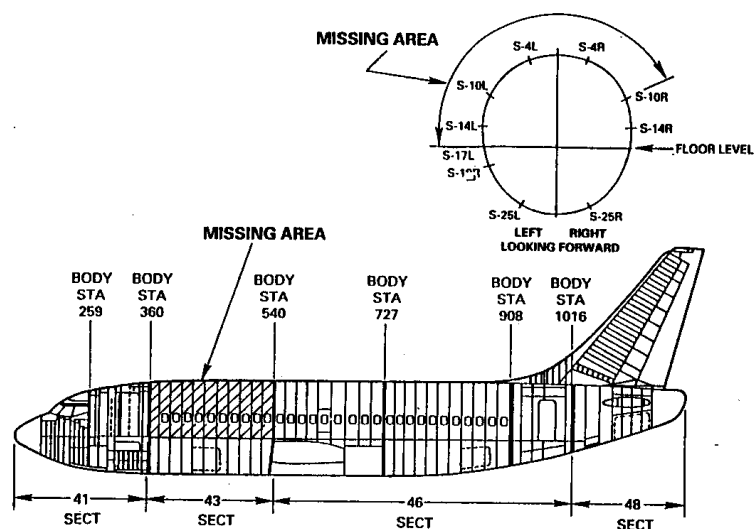
Figure 1.--Boeing 737-200--Body Stations, Stringers, and Section Locations.

A major portion of the upper crown skin and structure of section 43 separated in flight causing an explosive decompression¹ of the cabin. (See [figure 1](#) and [figure 2](#).) The damaged area extended from slightly aft of the main cabin entrance door, rearward about 18 feet to the area just forward of the wings and from the left side of the cabin at the floor level to the right side window level.

The area where the structure was missing extended from body station⁴ (BS) 360 aft to about BS 540, and circumferentially from just above the floor on the left side of the airplane (at S-15L), across the crown and down the right side to a position above the window belt (at S-10R). The structure from the top of the window belt to the floor on the right side was distorted severely and bent outward more than 90°. The skin had peeled in this area leaving the frames, stringers, and window forgings in place. On the left side below the floor level, the skin had peeled off the structure in large V-shaped areas.

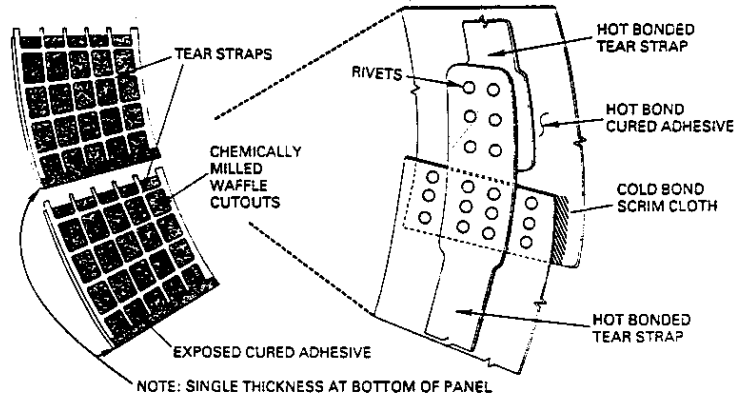
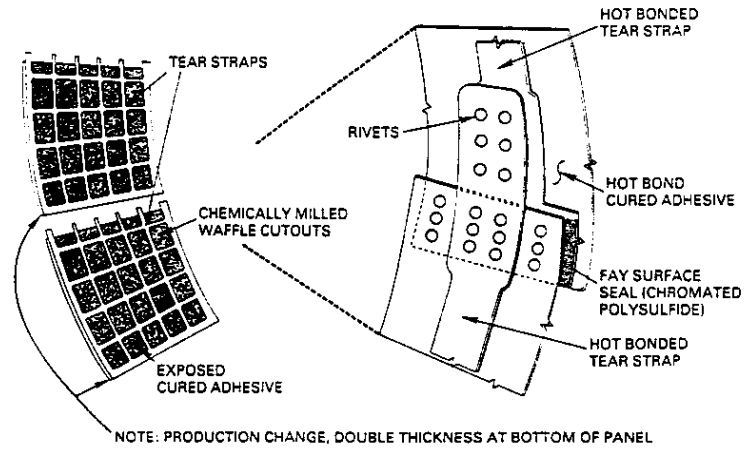
Figure 3.--B-737 Lap splice configuration

On the early model airplanes (through production line number 291), the doubler sheet was milled away chemically at the lap joint locations; for production line number 292 and the subsequent numbers, the doubler sheet was retained on the outer panel of each lap joint to provide an extra 0.036 inch of material thickness in the joint. (See [figures 3](#), [4a](#) and [4b](#).) Additionally, for production line number 465 and the subsequent numbers, an improved bond surface pretreat process using a phosphoric acid anodize was employed.

According to Boeing engineers, when disbond occurs in the bonded lap joint, as designed for the B-737, the hoop load transfer through the joint is borne by the three rows of countersunk rivets that mechanically fasten the skin panels together. Because of the single thickness skin surface that was facilitated by the bonded construction, the countersink for the flush rivet heads extended through the entire thickness of the outer 0.036-inch sheet. A knife edge was created at the bottom of the hole which concentrated stresses. These stresses were cyclic with pressurization loads, and fatigue cracking ultimately occurred at the site.

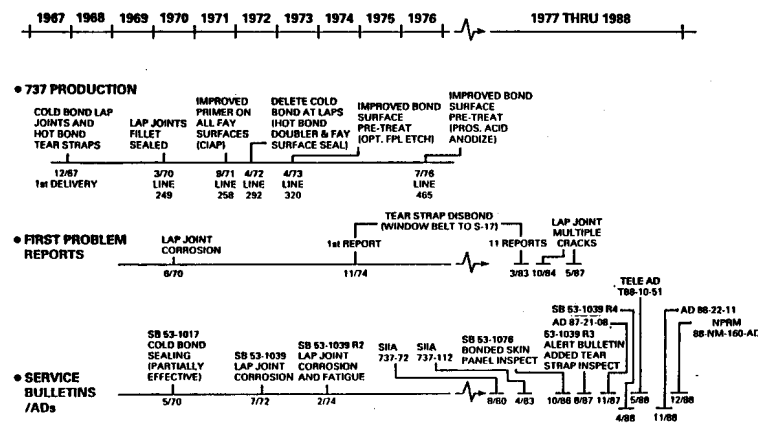
Figure 5.--Production, first problem reports, and Service Bulletins/ADs for 737 bonded body skin lap joints and tear straps

Random cracking at lap joints (See Section 1.17.4, Service Difficulty Report Information) on individual B-737 airplanes has occurred over time, related to the original quality of the joint bond and the environment in which the airplane operated. The rate of crack propagation has been dependent on, among other things, the degree of disbond at the given location within the joint and the accumulation by the airplane of equivalent full pressurization cycles.

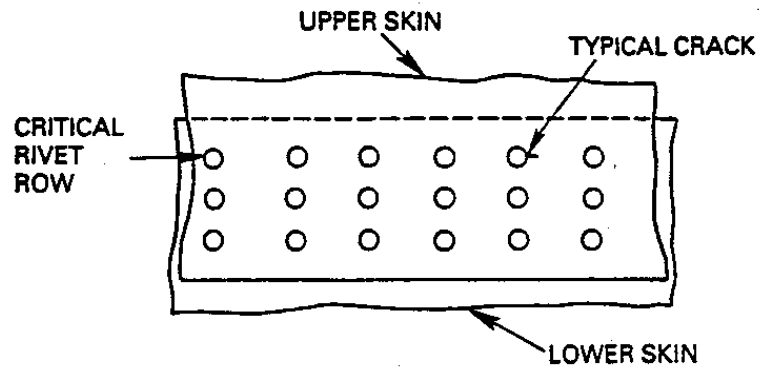
Figure 6a.--Typical lap joint

The lap joint piece, S-4L, from BS 519 to BS 536, exhibited fatigue cracking from 16 consecutive rivet holes along the upper row of lap joint rivets. The largest single fatigue crack in one direction measured 0.18 inch from the knife edge of the countersink. (See figure 6.) The longest total combined crack length in both directions across a rivet hole (end to end of the crack including the hole) measured 0.53 inch. Both the cold-bonded lap joint and the hot-bonded tear straps in this area had disbonded. Light to moderate corrosion was present on the previously bonded surfaces.
